QUINNIPIAC RIVER BASIN  
MERIDEN, CONNECTICUT

# BLACK POND DAM CT 00135

## PHASE I INSPECTION REPORT NATIONAL DAM INSPECTION PROGRAM

FEBRUARY, 1981

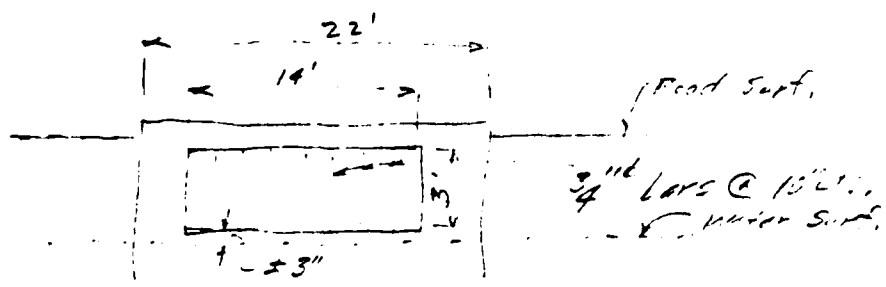
Upstream Elev. of Conc. Box Culvert  
Under Birdsey Ave.

Leak thru dam are on west  
side of spillway - at ground surface  
and about 10'-12' below top of  
dam.
